Preliminary Report on Field Training and Field Survey: Biophysical Soil and Land Health Assessment using the Land Degradation Surveillance Framework (LDSF) within the Regreening Africa Project

By Leigh Ann Winowiecki, Athanase Mukuralinda, Providence
Mujawamariya, Aida Tobella, and Tor-Gunnar Vågen
Contact: L.A.Winowiecki@cgiar.org
World Agroforestry (ICRAF)
June 2018

This report covers both the field training and the preliminary data analysis of the Biophysical Field Assessment carried out in Rwanda for the Regreening Africa project.

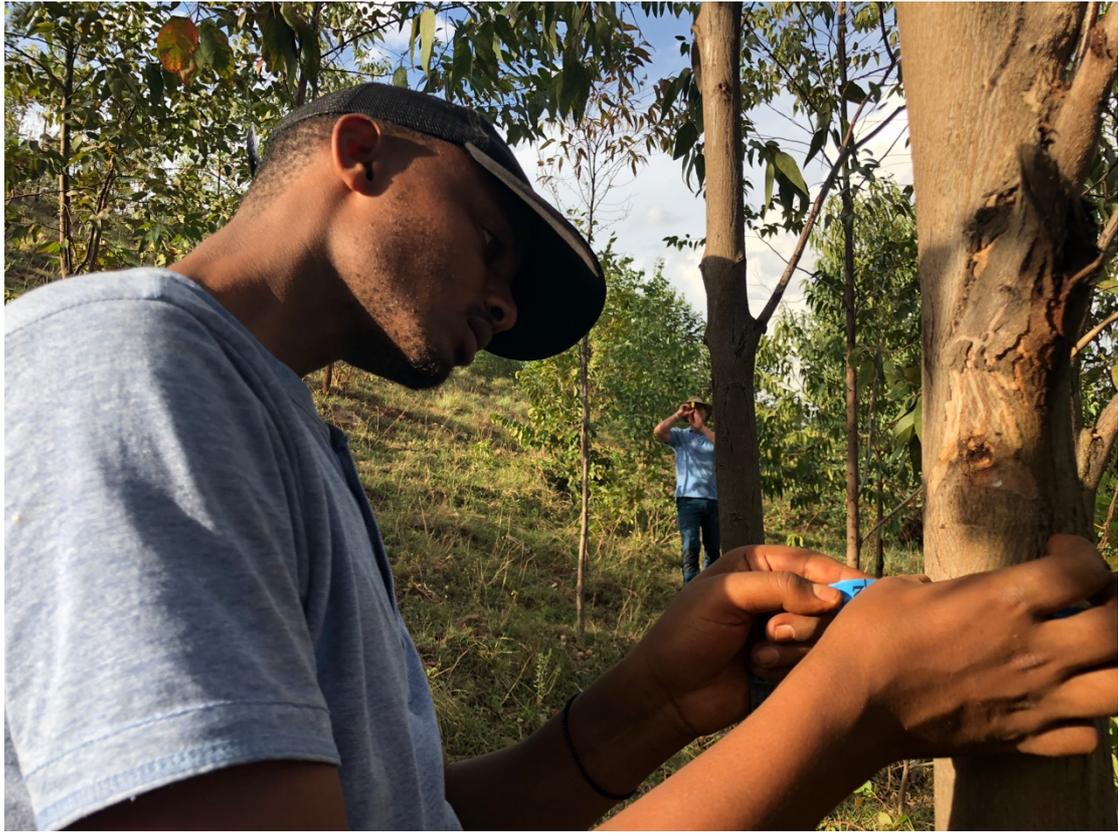
Figure 3: RAB Staff, Lambert Musengimana, measuring the diameter at breast height (DBH) of the Eucalyptus tree as part of the LDSF Tree Biodiversity module.

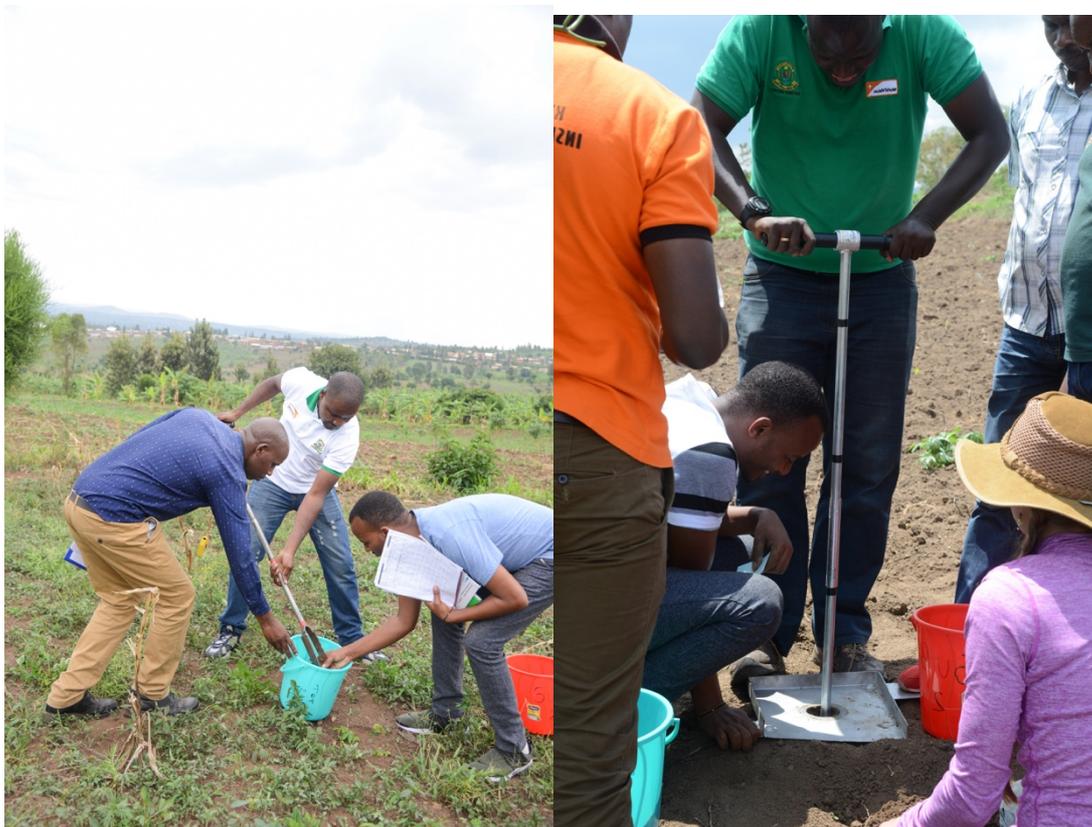
Figure 4: Alex Mugayi of World Vision-Rwanda collecting soil samples from Subplot 2 (left) and Patrick Rugema of World Vision-Rwanda collecting a cumulative soil mass sample from subplot 1.

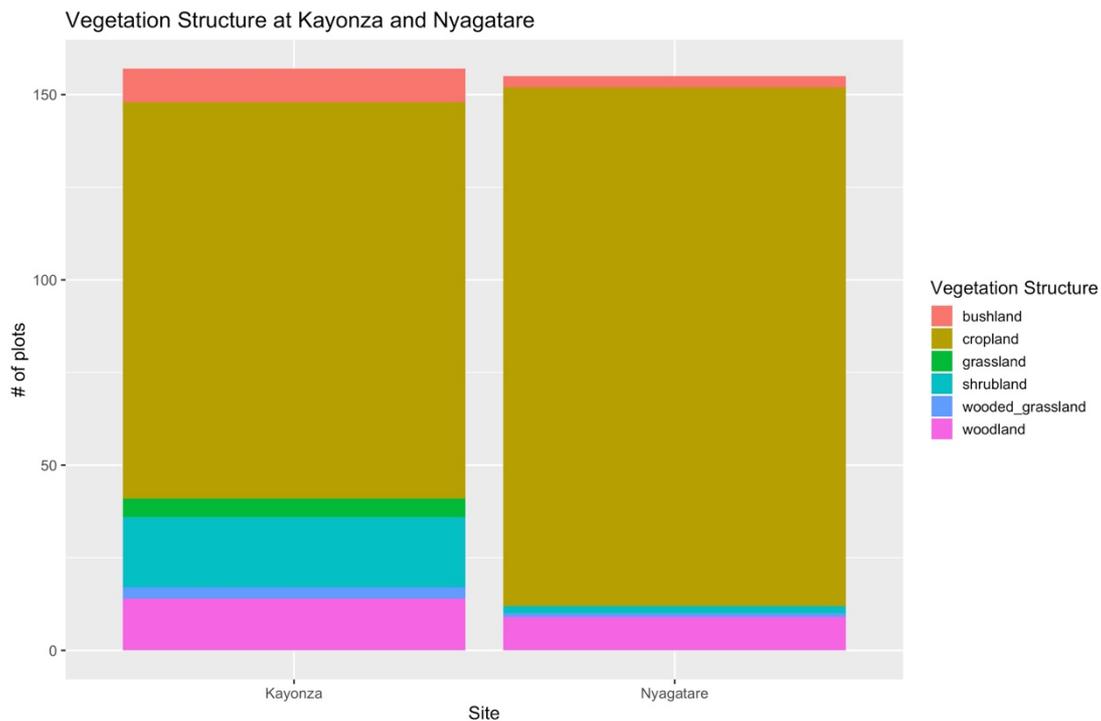
Figure 6: Number of plots classified as bushland, cropland, grassland, shrubland, wooded grassland or woodland for both sampled LDSF sites. Both sites were dominated by annual cropland.

The LDSF uses the FAO Land Cover Classification System (LCCS), which was developed in the context of the FAO-AFRICOVER project. Each sampled plot was classified by the vegetation structure. Figure 7 shows the number of each plot per site under each classification.

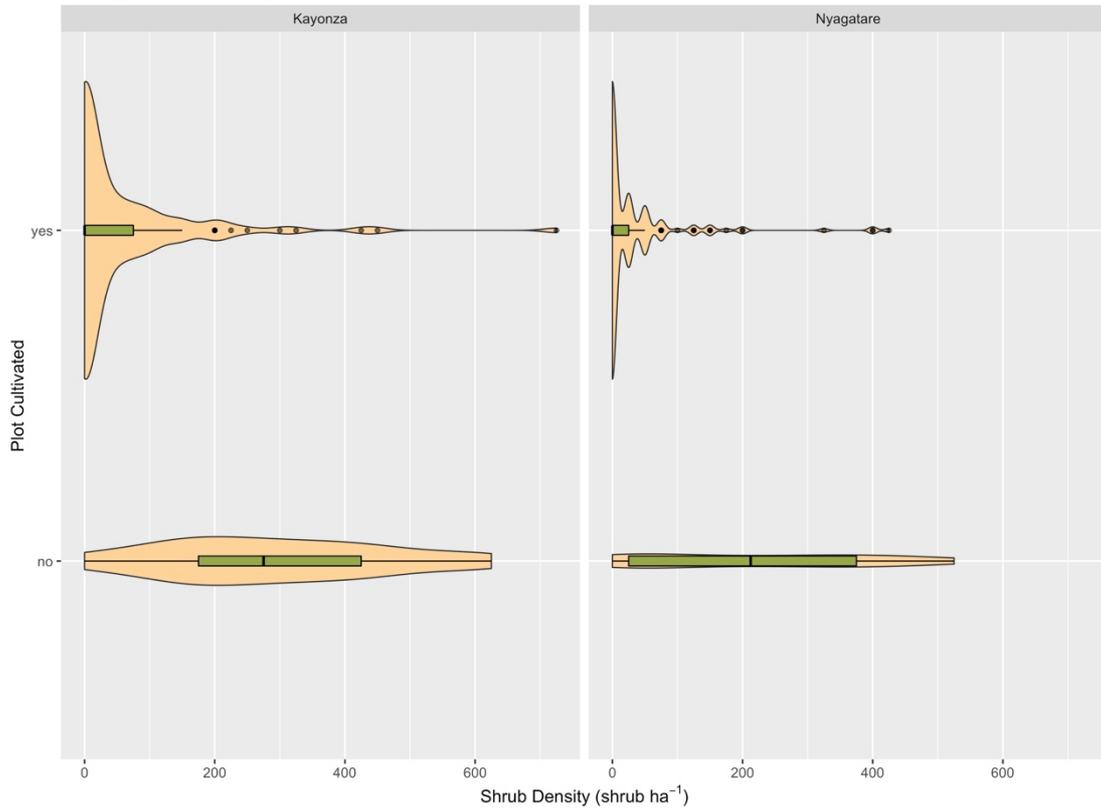
Average Shrub Density in Cultivated and Non-cultivated Plots

Figure 7: Average shrub densities in cultivated and non-cultivated plots.

Averages shrub density was higher in non-cultivated plots in Kayonza (317 shrubs per ha) compared to 79 shrubs per ha in cultivated plots. Average shrub density was lower in Nyagatare with an average of 44 shrubs per ha in cultivated plots and 225 shrubs per ha in non-cultivated plots (Figure 8).

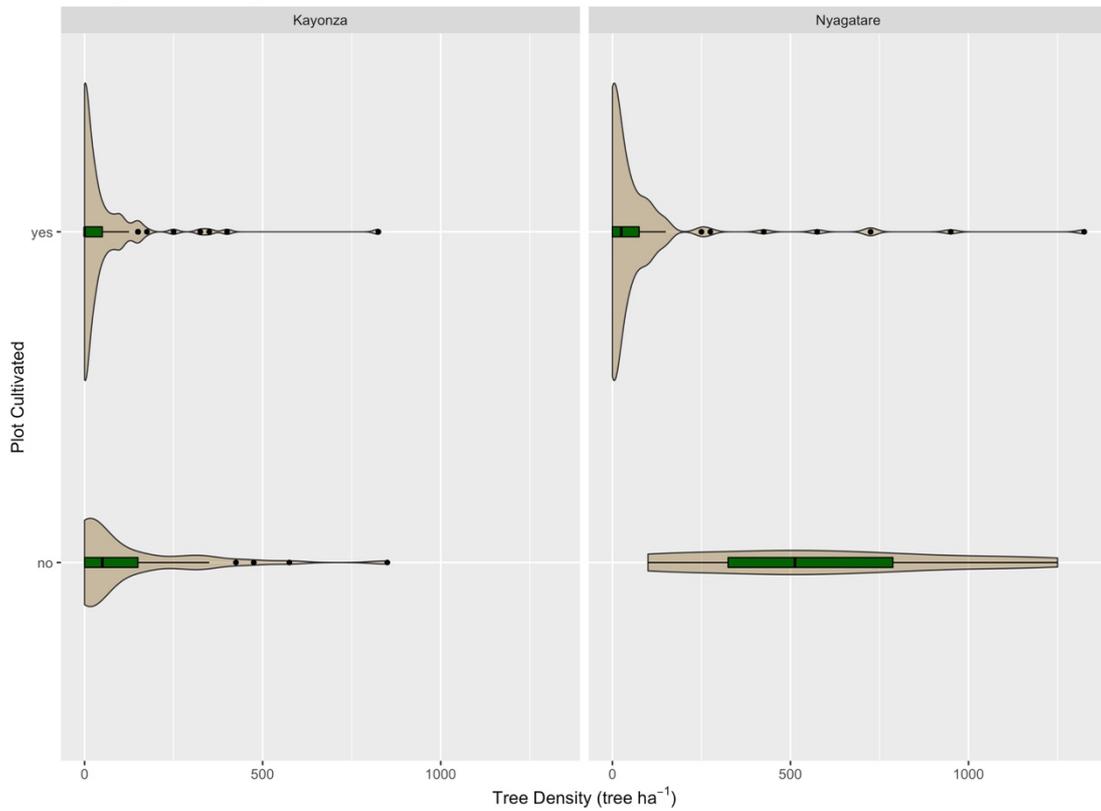
Average Tree Density in Cultivated and Non-cultivated Plots

Figure 8: Average tree densities in cultivated and non-cultivated plots.

Average tree density was higher in cultivated plots in Kayonza (75 trees per ha) compared to 46 trees per ha in non-cultivated plots. In contrast, the average tree density was 120 trees per ha in cultivated plots in Nyagatare and 186 trees per ha in non-cultivated plots (Figure 9).

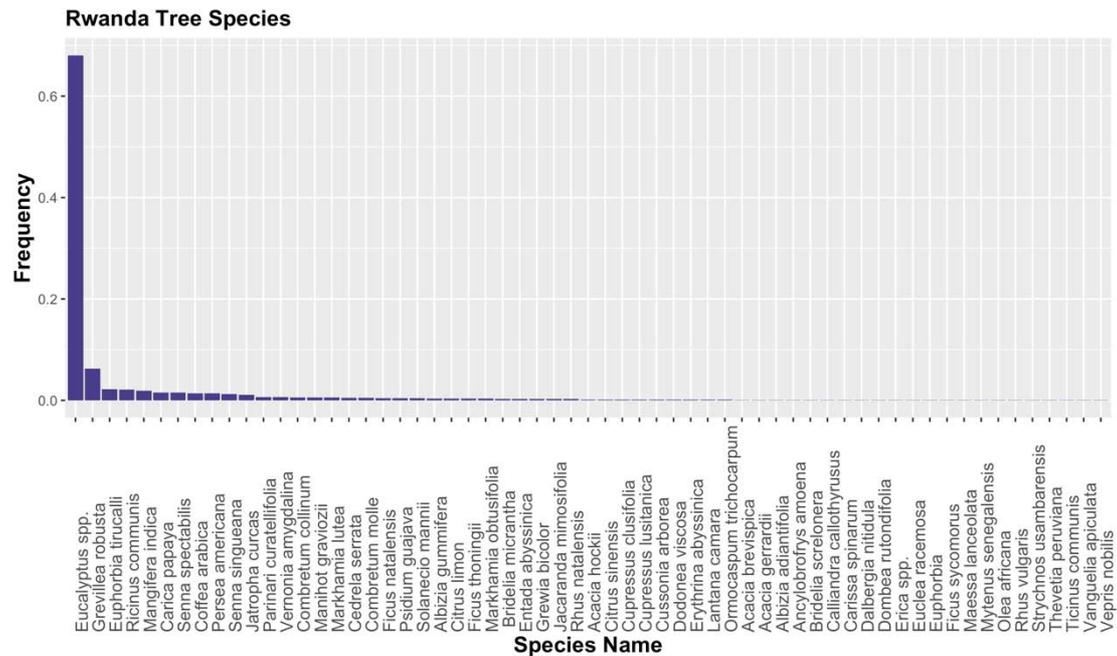
Figure 9: Overall tree species occurrence across the two LDSF sites.

Trees were identified in each 100-m² subplot (n=4 per plot). In total 62 unique tree species were identified in the two LDSF sites. The most common species were: *Eucalyptus* spp., *Grevillea robusta*, *Euphorbia tirucalli*, *Ricinus communis*, *Mangifera indica*, *Carica papaya* and *Senna spectabilis* (Figure 10). Differences were observed between the two LDSF sites, most notably that *Jatropha curcas* was only found in Kayonza and *Senna singueana* was only found in Nyagatare. In summary, 48 unique species were observed in Kayonza and 39 species in Nyagatare (Figure 11).

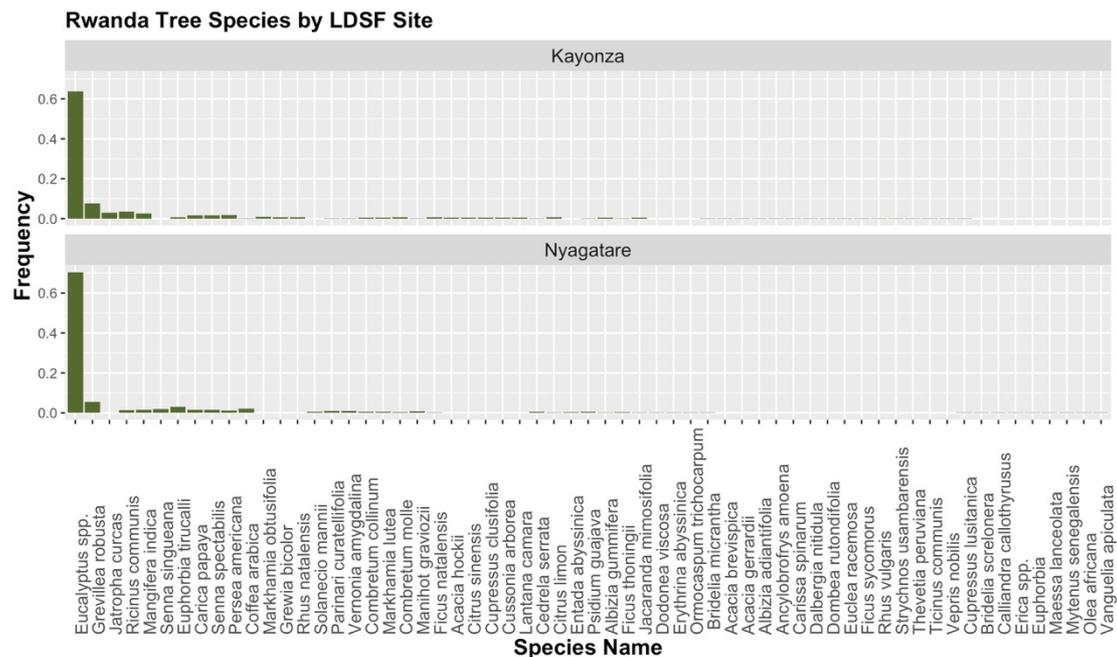
Figure 10: Tree species occurrence at Kayonza (top panel) and Nyagatare (bottom panel).

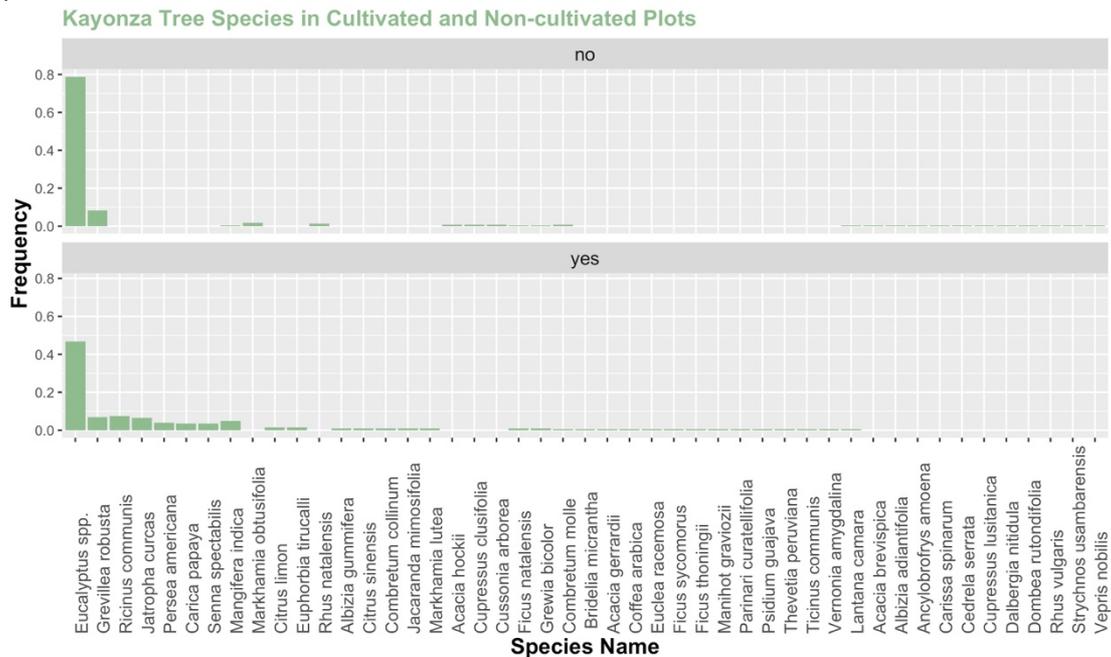
Figure 11: Kayonza tree species in cultivated (yes) and non-cultivated (no) plots.

In Kayonza, 24 unique species were observed in non-cultivated plots, while 32 species were observed in cultivated plots. Figure 12 illustrates the species occurrence in cultivated and non-cultivated plots.

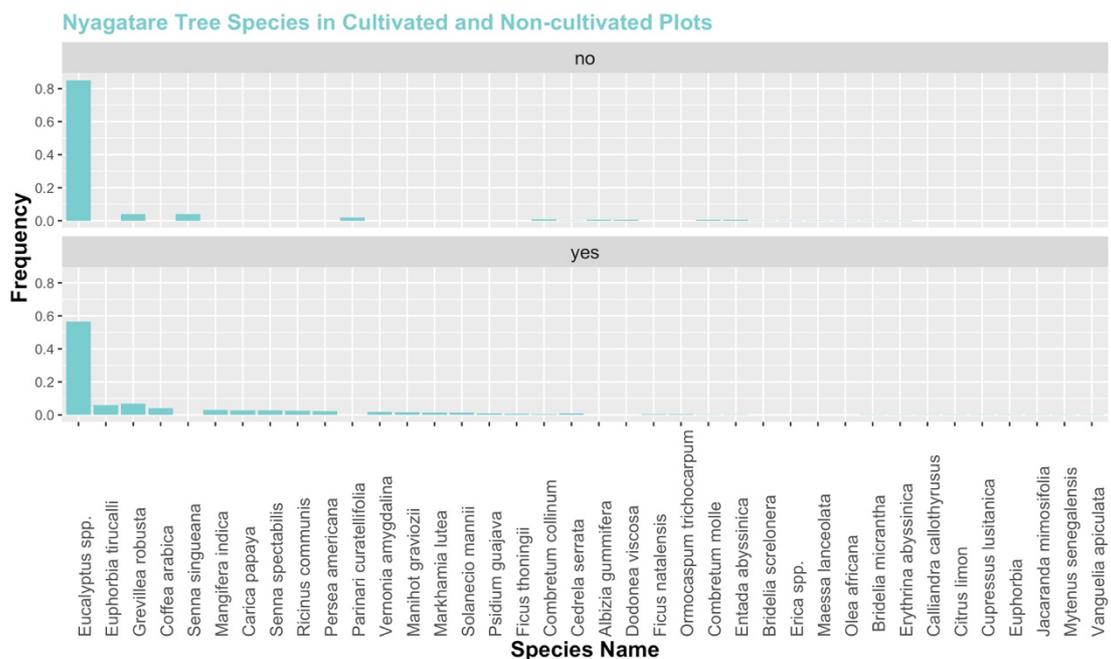
Figure 12: Nyagatare tree species in cultivated (yes) and non-cultivated (no) plots.

In Nyagatare, 17 unique species in non-cultivated plots and 32 unique species were identified in cultivated plots and only (Figure 13). Note that most of the sampled plots in each site were cultivated.

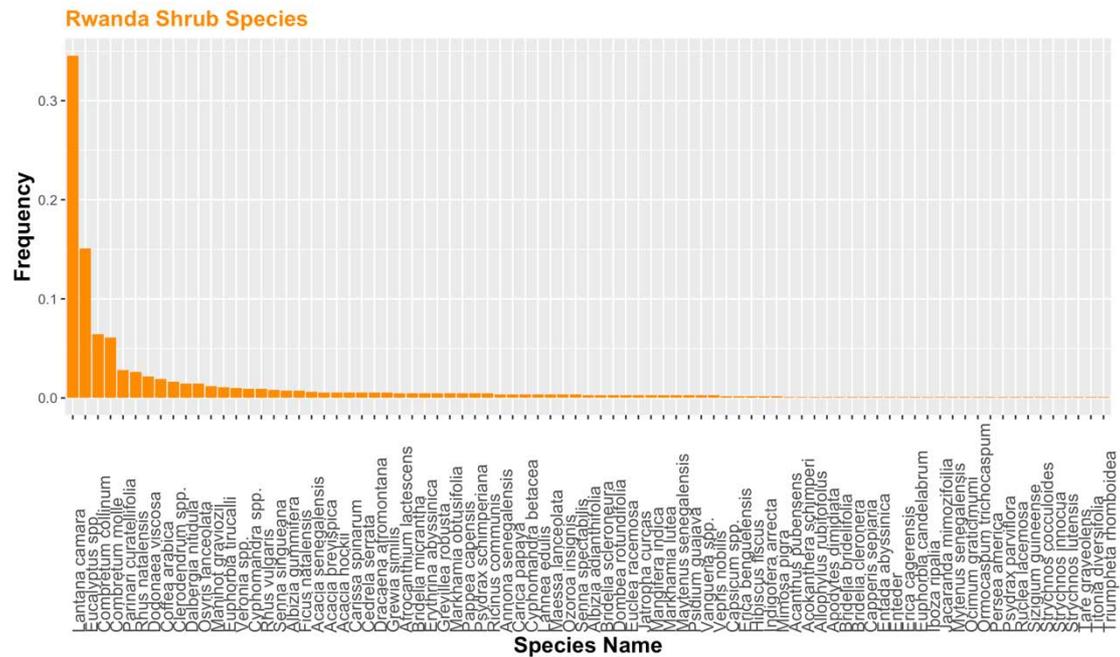
Figure 13: Overall shrub species at the two LDSF sites.

Shrubs are classified as woody vegetation between 1.5 m and 3 m tall. In total, 84 unique shrub species were identified. The most common shrub in the Kayonza site was *Lantana camara*, an invasive and the most common shrub in the Nyagatare site was *Eucalyptus* spp (Figure 14).

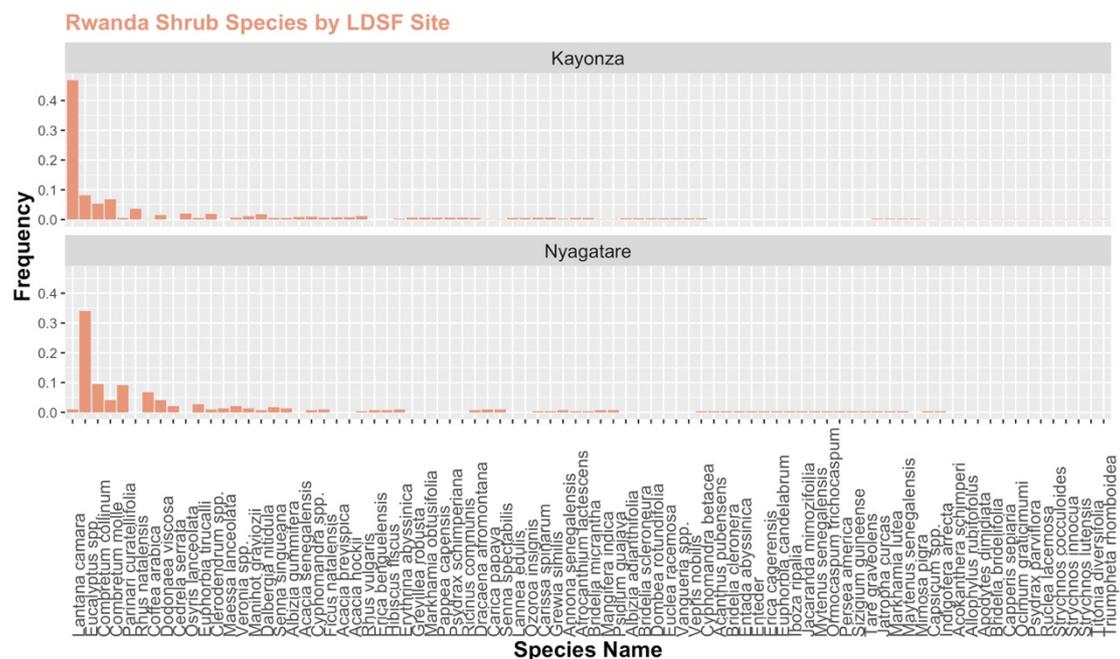
Figure 14: Shrub species occurrence at the two LDSF sites.

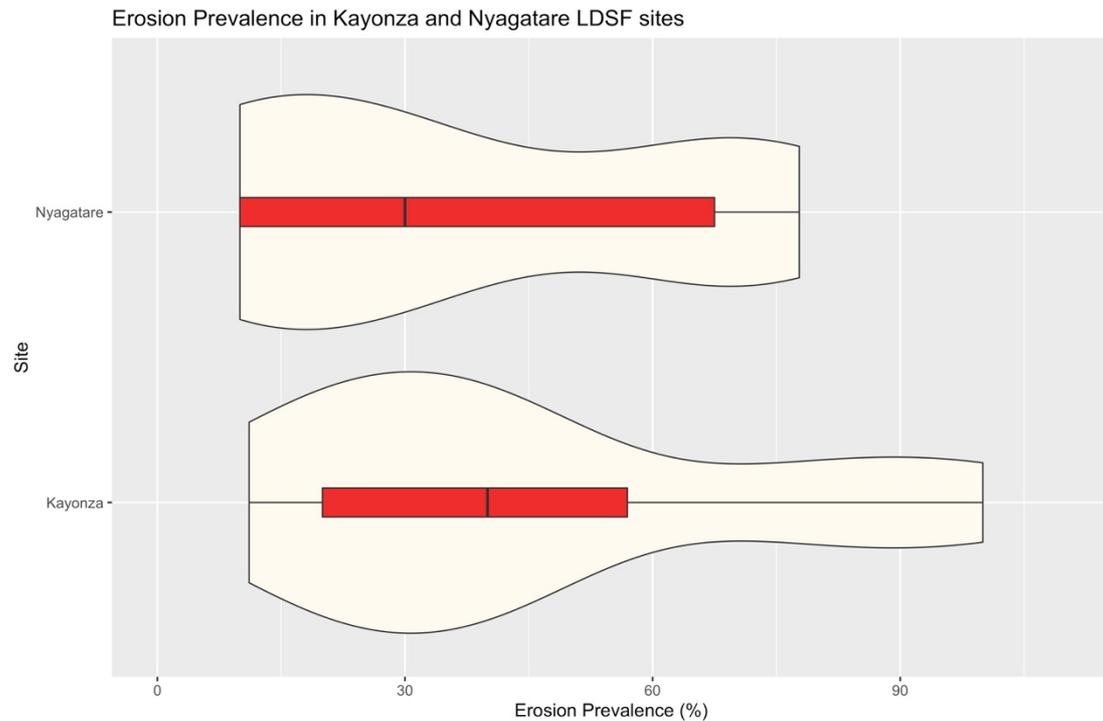
Erosion was scored and classified in each subplot (n=4) per plot. The below graphic shows the percent of plots classified as having severe erosion. Erosion prevalence was on average higher in Kayonza (45%) compared to Nyagatare (27%).

Figure 15: Erosion prevalence in the two LDSF sites, represented by boxplots. The black vertical line within the boxplot indicates the median value. Note, boxplots show the variation that exists within the sites.

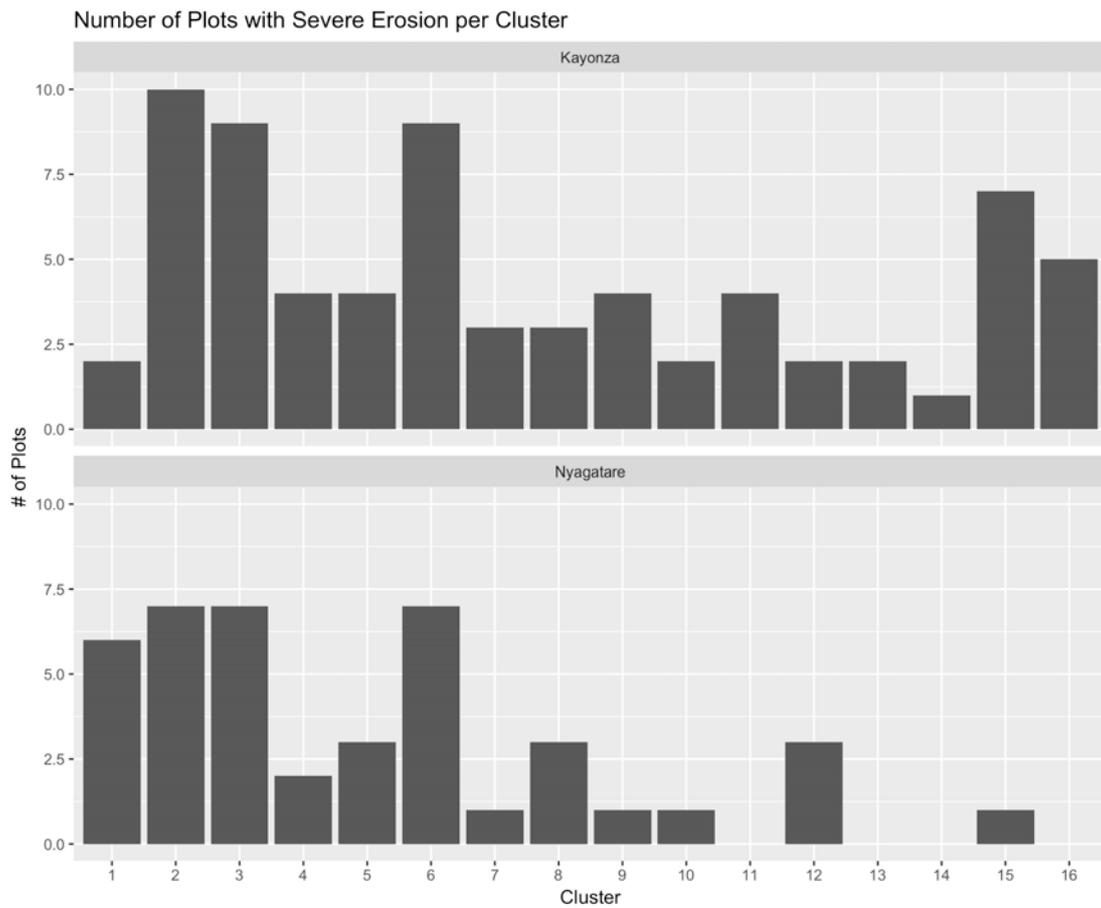
Figure 17: Bar charts of the number of plots per cluster that had severe erosion. Note that in Kayonza site, cluster 2,3,6, and 15 had more than five plots with severe erosion. In Nyagatare, clusters 11,13,14, and 16 had no plots with severe erosion. In general, 10 plots were sampled per cluster.

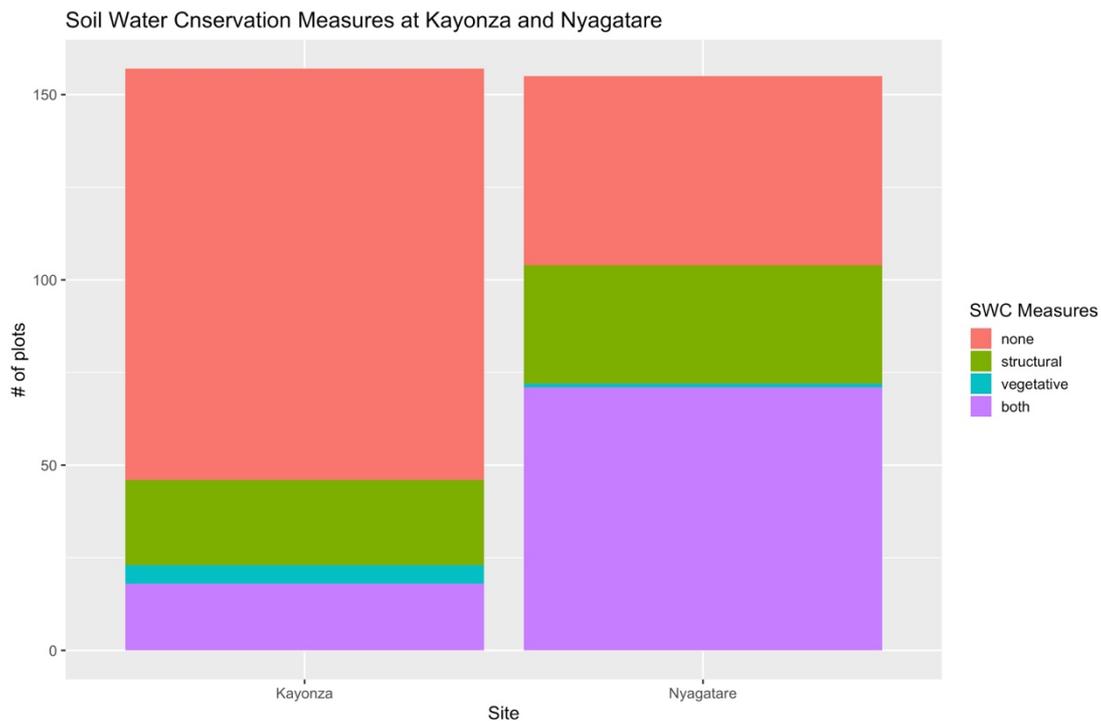
Soil water conservation measures were classified and counted at each plot. The below graphic shows the number of plots with structural, vegetative, or both structural and vegetative measures. Note that Nyagatare had higher presence of SWC measures compared to Kayonza.

Figure 18: Presence of soil water conservation measures.

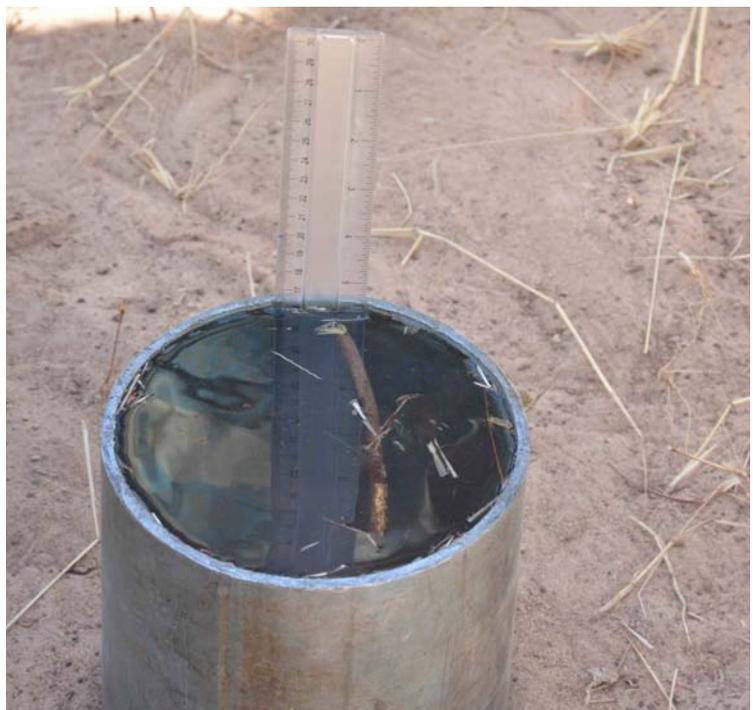
Infiltration capacity was measured at three plots per cluster in each site using single ring infiltrometers to assess variation across land uses and soil types. Soil infiltration capacity into dry soils follows a predictable temporal pattern: it is high in the early stages of infiltration and tends to decline gradually with time until it eventually approaches a nearly constant rate known as steady-state infiltration capacity.

Figure 19: Photo of the single ring infiltrometer used to measure infiltration in the field. Photo: G. Koffi/ICRAF.

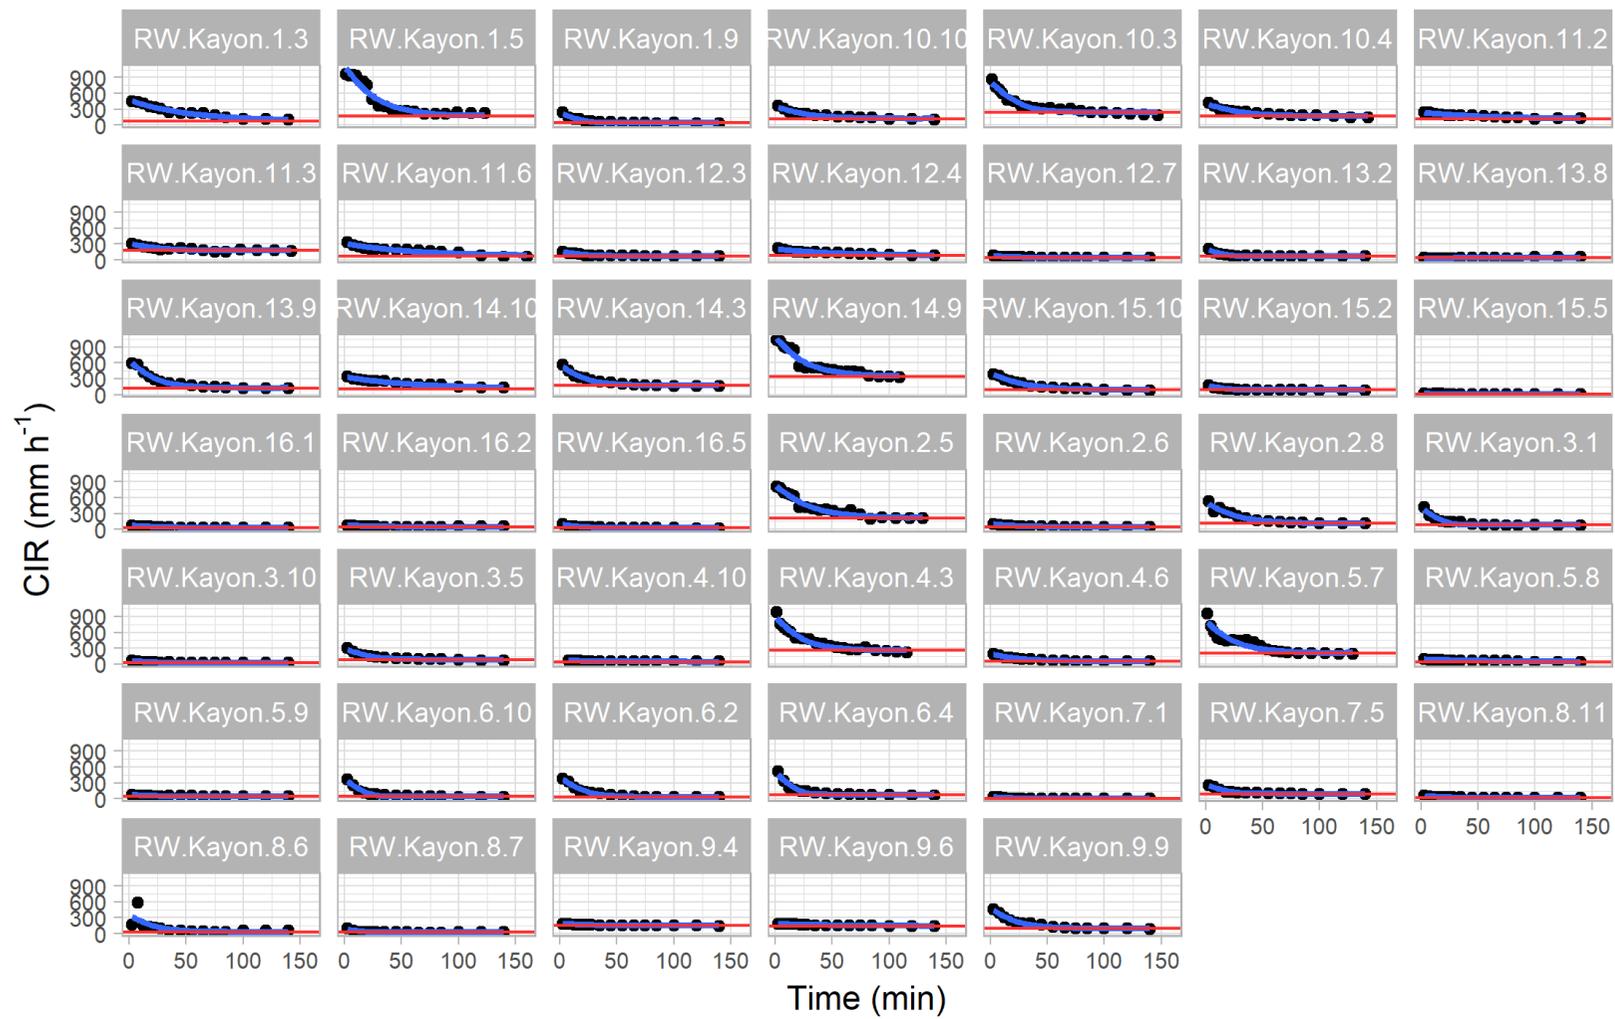
Corrected infiltration capacity rates over time, and the modeled infiltration curves and steady-state infiltration capacity (which corresponds to the estimated soil saturated hydraulic conductivity, *i.e.*, K_s) for each plot in which infiltration was measured (Figures 18 & 19). Note the variation across the sites, for example, RW.Kayon.2.5 and RW.Kayon.4.3 had faster infiltration rates compared to several other plots.

Figure 20: Corrected infiltration rates (black dots), modelled infiltration curve (blue line) and modelled saturated hydraulic conductivity (red line) for each plot in which infiltration was measured in Kayonza LDSF site.

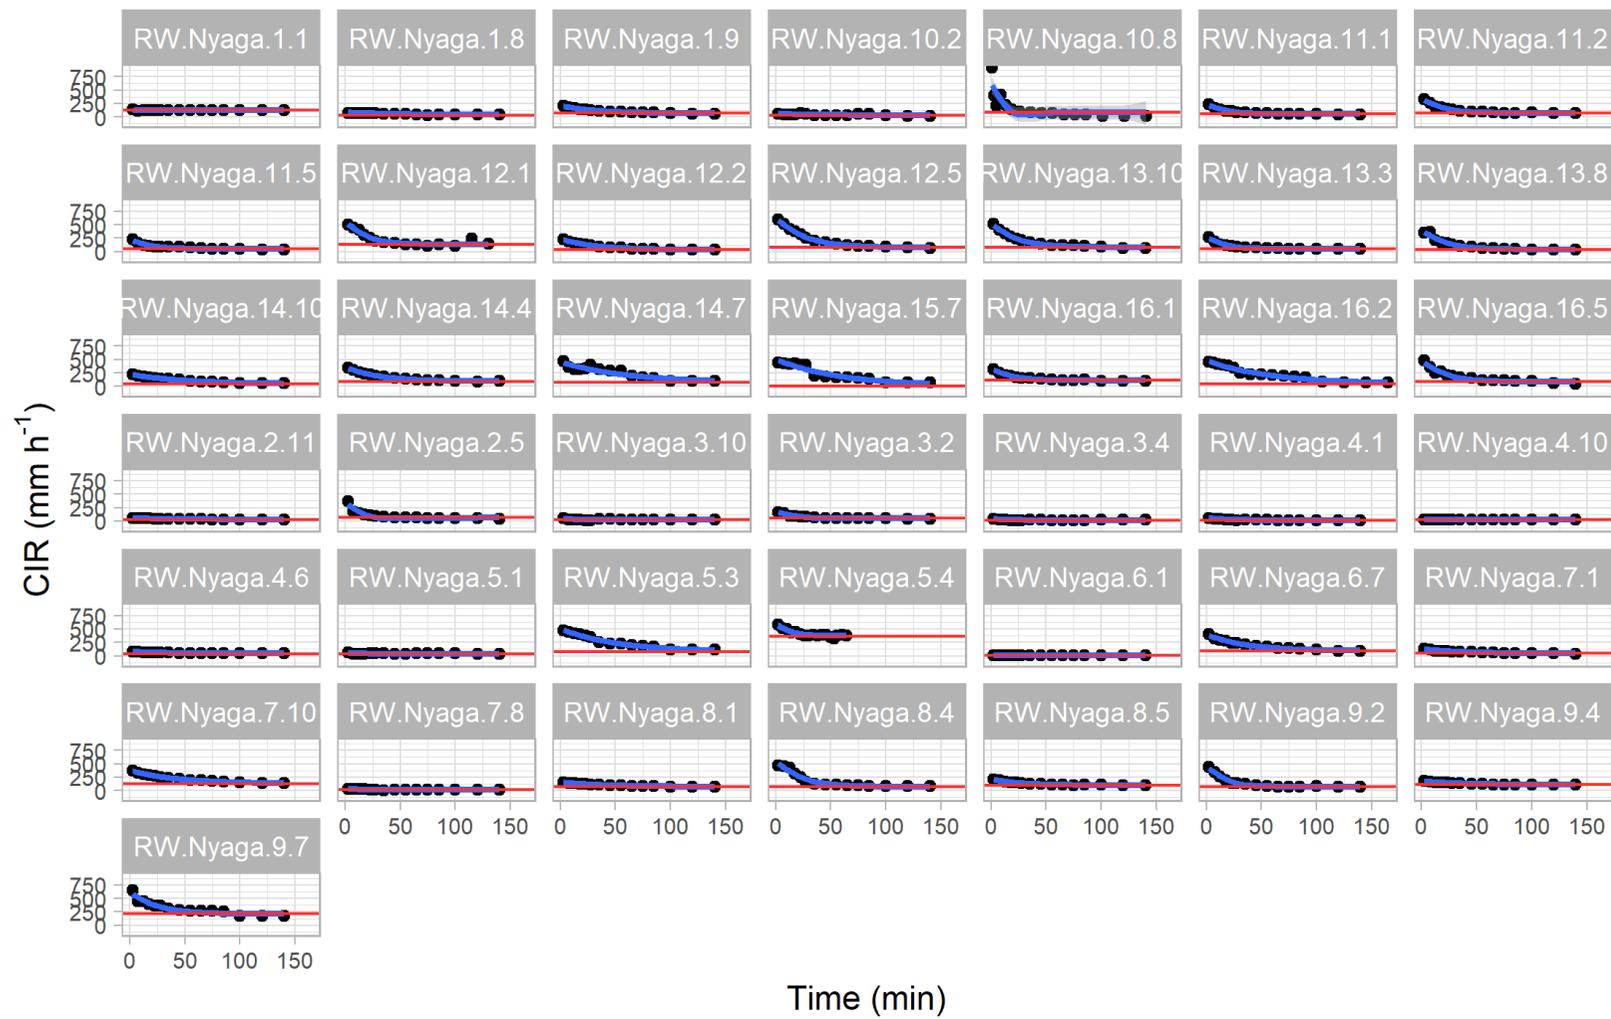
Figure 21: Corrected infiltration rates (black dots), modeled infiltration curve (blue line) and modelled saturated hydraulic conductivity (red line) for each plot in which infiltration was measured in Nyagatare LDSF site.

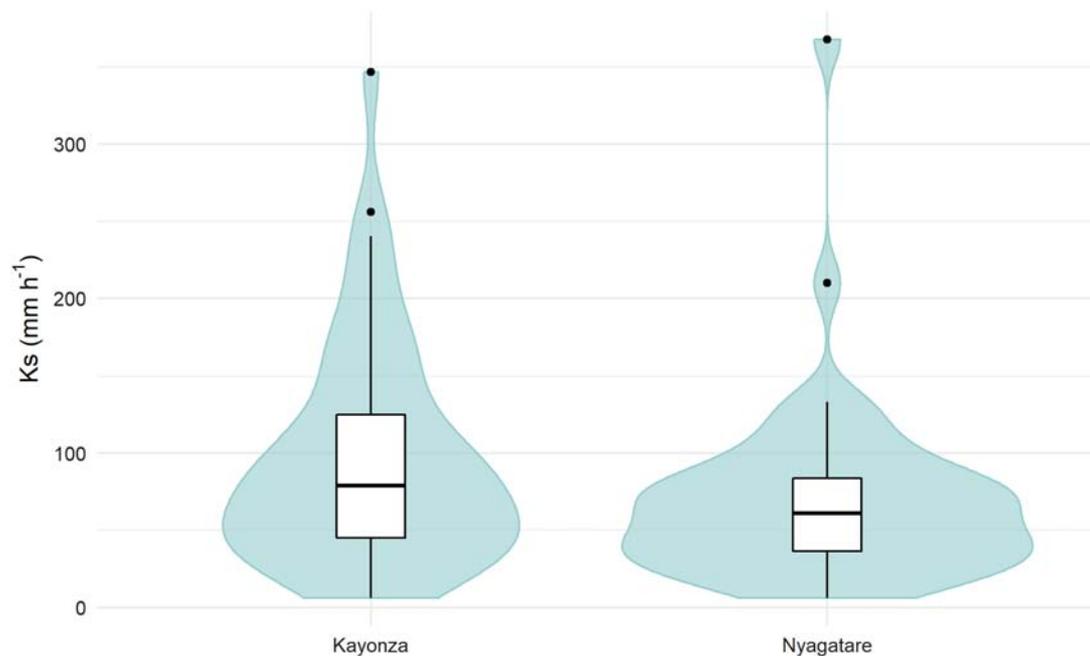
Modeled saturated hydraulic conductivity (K_s) ranged between 6 and 368 mm h^{-1} , and was higher in Kayonza compared to Nyagatare, with median values of 79 and 61 mm h^{-1} , respectively (Figure 20).

Figure 22: Box and violin plots of the modeled saturated hydraulic conductivity (K_s) for each site. The three horizontal lines in the box plot show the first quartile, the median, and the second quartile. Whiskers extend to the outer-most data point that falls within 1.5 box lengths. The violin plots show the distribution of the K_s data.
